Road M9-0.0-0.53, High Priority Road Drainage Improvement and Revegetation

PROJECT: Road M9-0.0-0.53, High Priority Road Drainage Improvement and Revegetation
Big River Unit
Mendocino Headlands State Park, Mendocino, CA

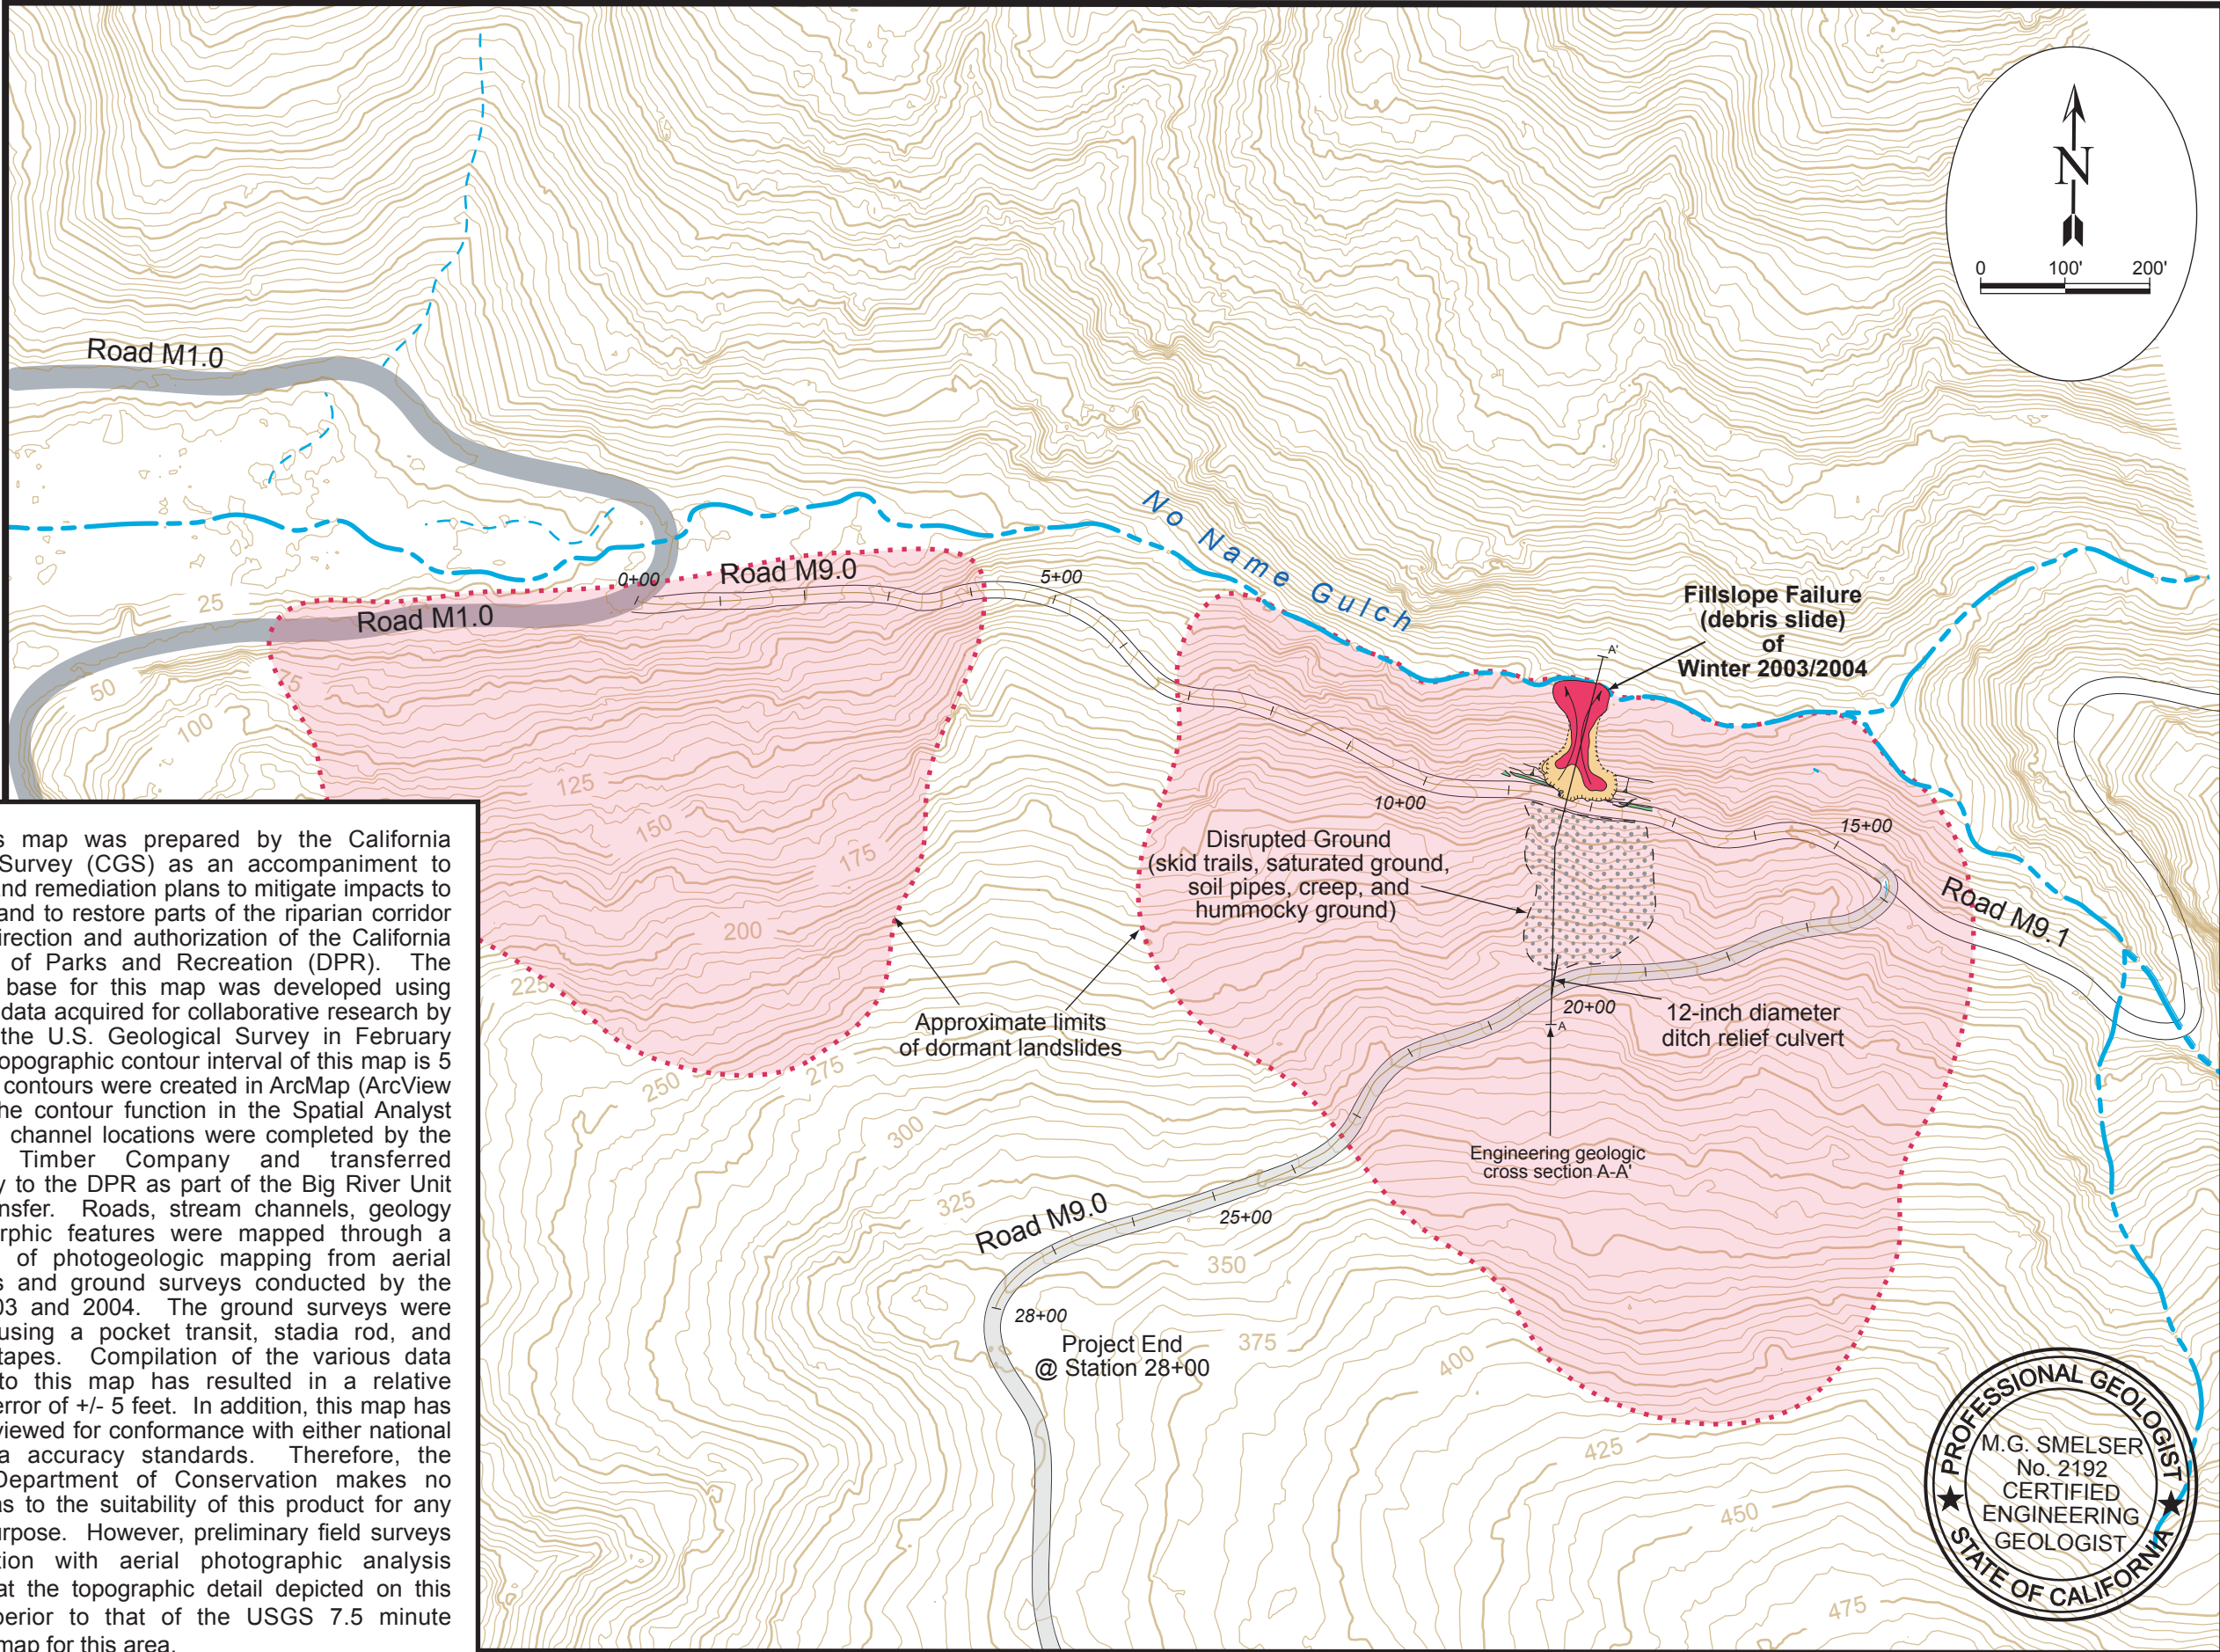
SHEET: 3 of 4	TITLE: Plan Sheet 3, Map of Road M9.0 & Fillslope Failure SCALE: 1 inch = 200 feet DATE: February 27, 2006	PROJECT: Road M9-0.0-0.53, High Priority Road Drainage Improvement and Revegetation Big River Unit Mendocino Headlands State Park, Mendocino, CA
----------------------	--	---

- ☐ 6) ☐ at its narrowest point the failure has reduced the roadway ☐ ☐ width to 12 feet;
- ☐ 7) ☐ soil pipes in the headscarp indicate that significant volumes ☐ ☐ of near-surface groundwater helped saturate the fillslope at ☐ ☐ this location; and

In summary, the analysis of contributing factors strongly indicates that several aspects of the existing roadway drainage system failed resulting in the accumulation of a significant amount of water along the road at this location. The accumulation in turn leading to saturation and eventual failure of the weak and poorly constructed fillslope along with some underlying native material at this location. The failed roadway drainage system continues to cause rill erosion within the landslide scar area. In conclusion, the minimal level of maintenance appears to require: 1) repair and enhancement of the roadway drainage system; and 2) erosion control and revegetation of the landslide scar area.

0+00 to 28+00 Using hand labor, clear the inside ditch and construct waterbars at 100-foot intervals (unless otherwise specified) under the direction of the PI; waterbars shall be constructed with PI approval at natural landscape swales located at approximate stations 0+80, 1+80, 3+15, 6+80, 10+00, 13+70, 18+25, 21+30, 23+30 and 26+10.

11+20 to 12+50 Ensure no ponding of water along the road within this area and no discharge of water onto the scar area from the road.

11+20 to 12+50 Using hand labor within the scar area of the recent fillslope failure, construct small check dams (rock piles) in the established erosional rills under the direction of the PI; enhance existing bench areas as drainage control areas as well as for concentrated plantings; terrace and revegetate scarred area under the direction of DPR ecologists.

19+00 to 20+50 Plug the existing ditch relief culvert under the direction of the PI and allow no roadway runoff onto the slope area that is above the failed roadway section.
